## Test report

# Linear joint seals

File           PGA10373b  
Serial No.:   14344  
Ref.:         CAN/TDJ  
Pages:        7  
Encl.:         30

DS/EN 1366-4:2006+A1:2010 Fire resistance tests for service installations- Part 4: Linear joint seals, Annex A Standard condition for linear joint seals with no mechanically induced movement of the joint faces.

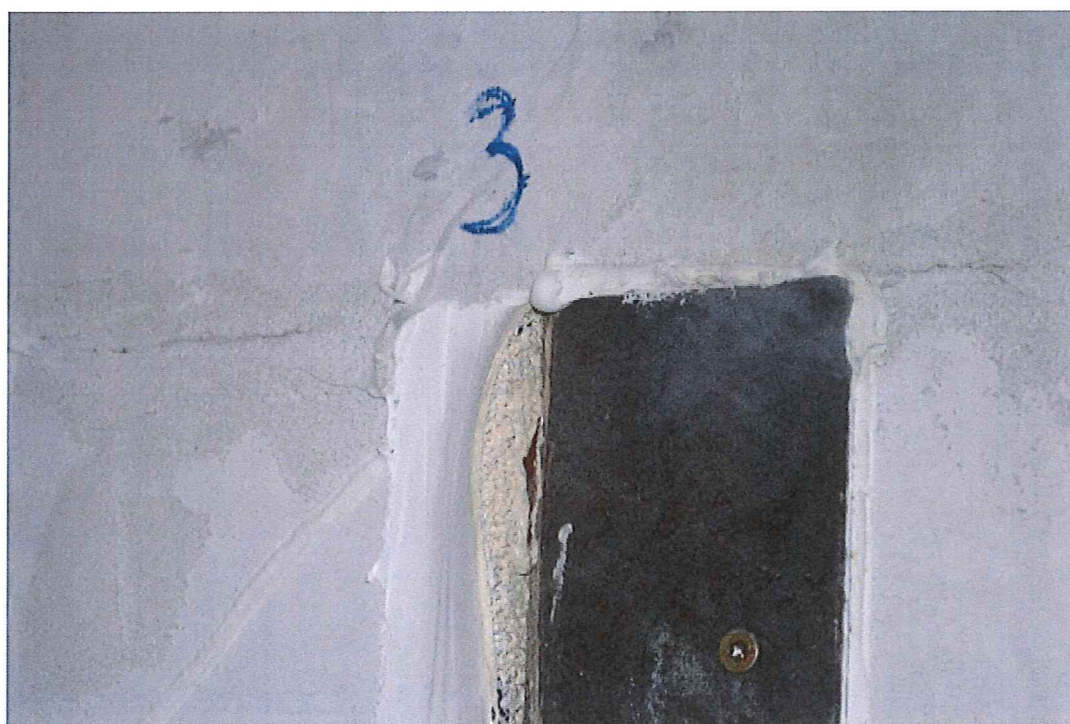
| Time minutes | Test specimen | Observations |
|---|---|---|
| 57 | 3 | Failure of integrity, due to trough going opening in the top of the sealant. |
| 58 | 3 | Hole is stopped with ceramic wool. |

| Test specimen | Test results | | | | |
|---|---|---|---|---|---|
| 3 | - | 51 | - | 51 | 57 |

Photo No. 6 Integrity failure at the top of joint seal 3 after 57 minutes of testing

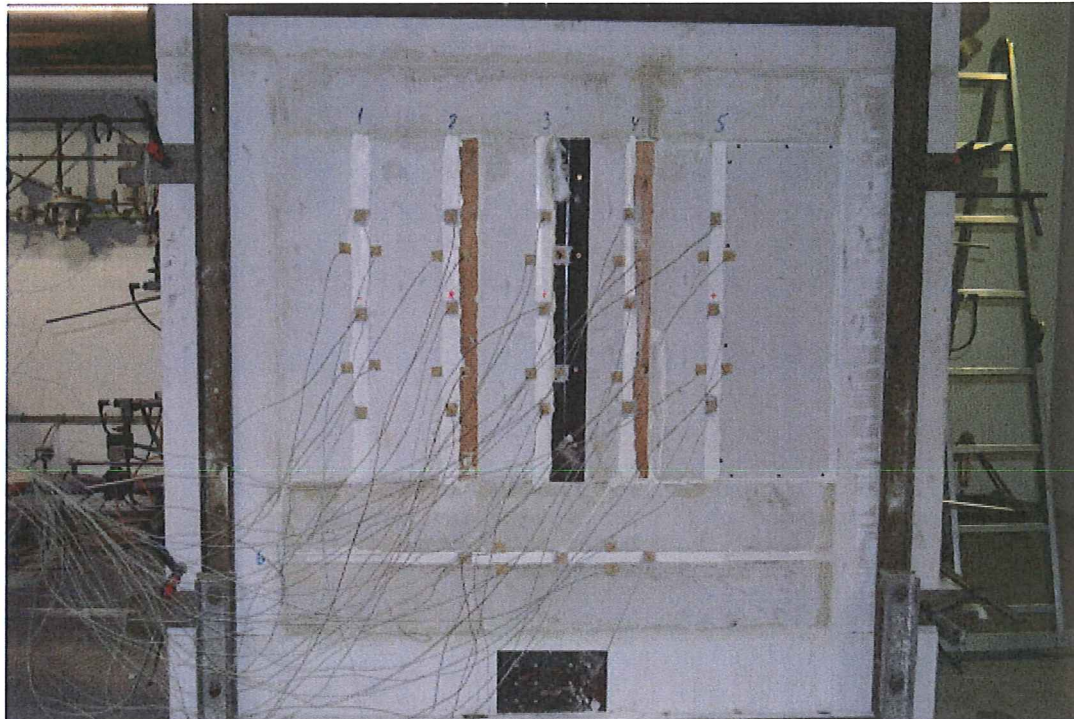
| 60 | 5 | The gypsum plasterboard supporting construction has deflected approx. 1 mm towards the furnace. |

Photo No. 7 Unexposed side of test specimen after 60 minutes of testing

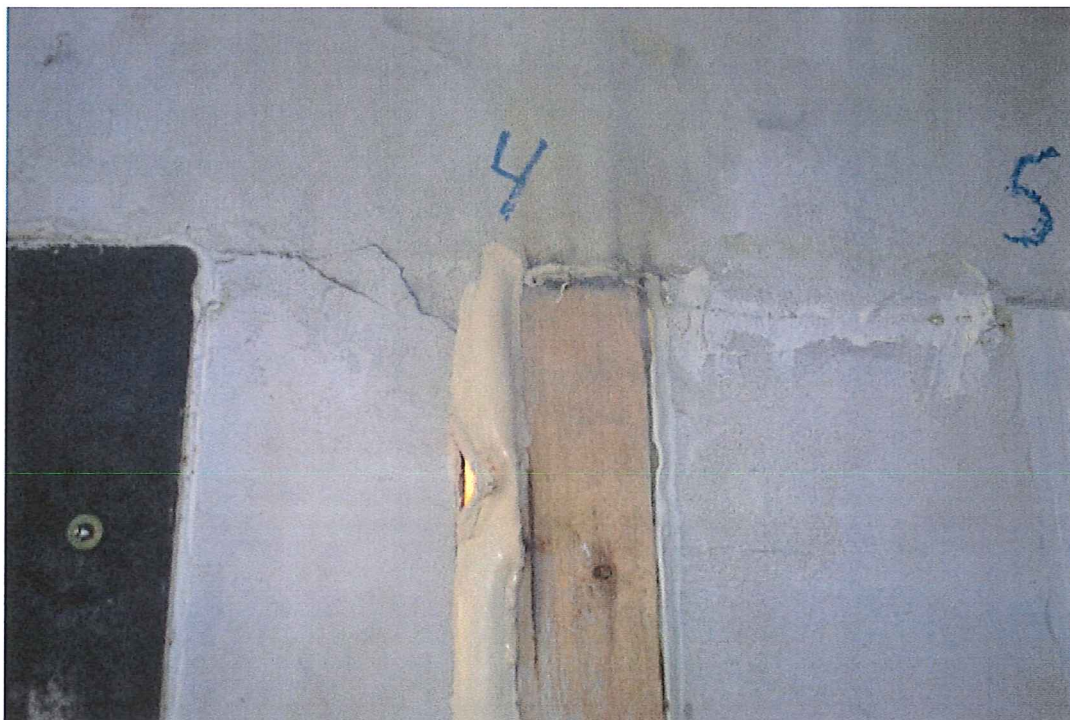
| 90 | 4 | Failure of integrity, due to trough going opening in the top of the sealant. Hole is stopped with ceramic wool. |

| Test specimen | Test results | | | | |
|---|---|---|---|---|---|
| 4 | 100 | - | - | 90 <sup>1</sup> | 90 |

Photo No. 9 Integrity failure at the top of joint seal 4 after 90 minutes of testing

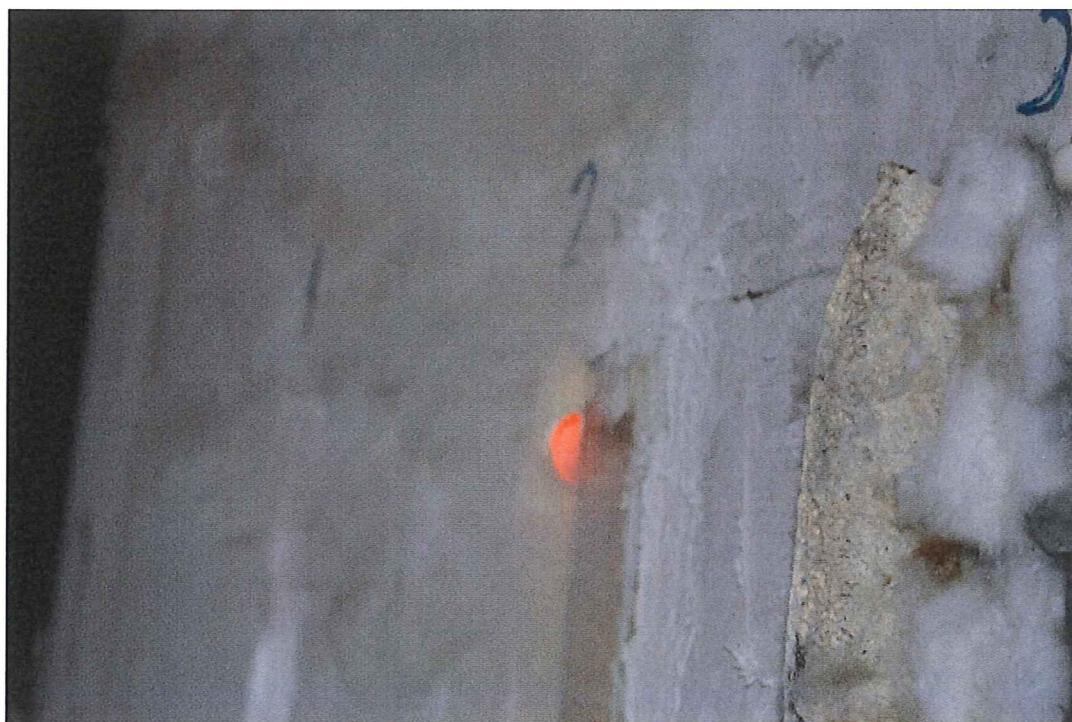
| 96 | 2 | Failure of integrity, due to trough going opening in the top of the sealant. Hole is stopped with ceramic wool. |

| Test specimen | Test results | | | | |
|---|---|---|---|---|---|
| 2 | 125 | - | - | 96 <sup>1</sup> | 96 |

Photo No. 10 Integrity failure at the top of joint seal 2 after 96 minutes of testing

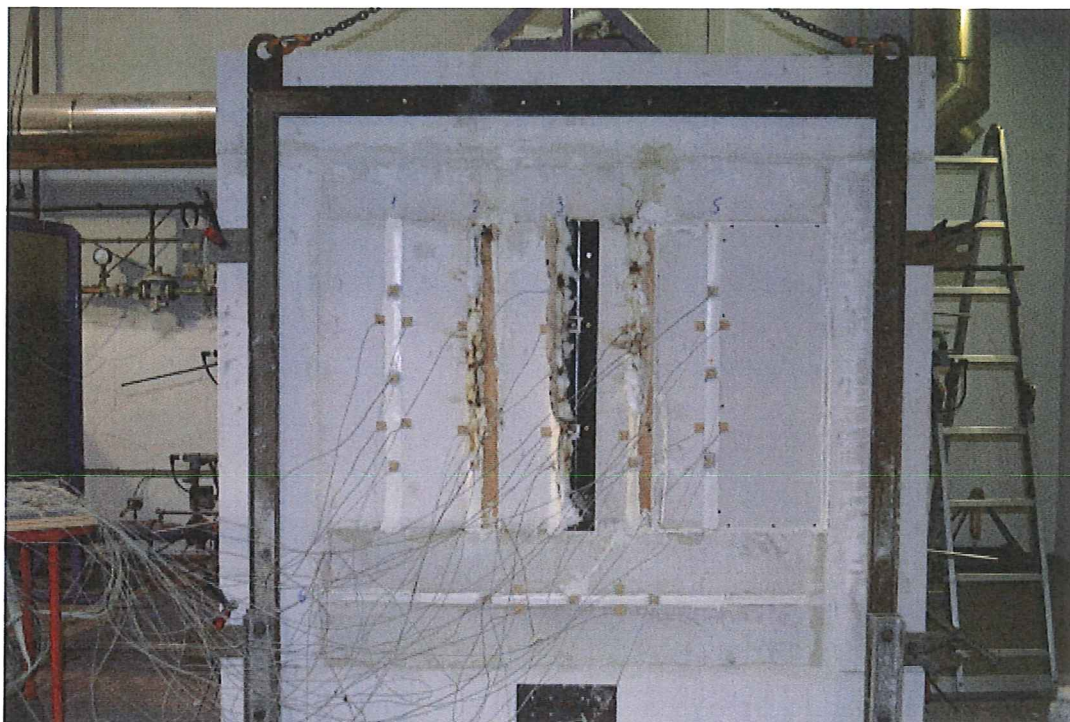
| 120 | 1/5/6 | Integrity of sealants sustained. The gypsum plasterboard supporting construction has deflected approx. 3 mm towards the furnace |

Photo No. 11 Unexposed side of test specimen after 120 minutes of testing

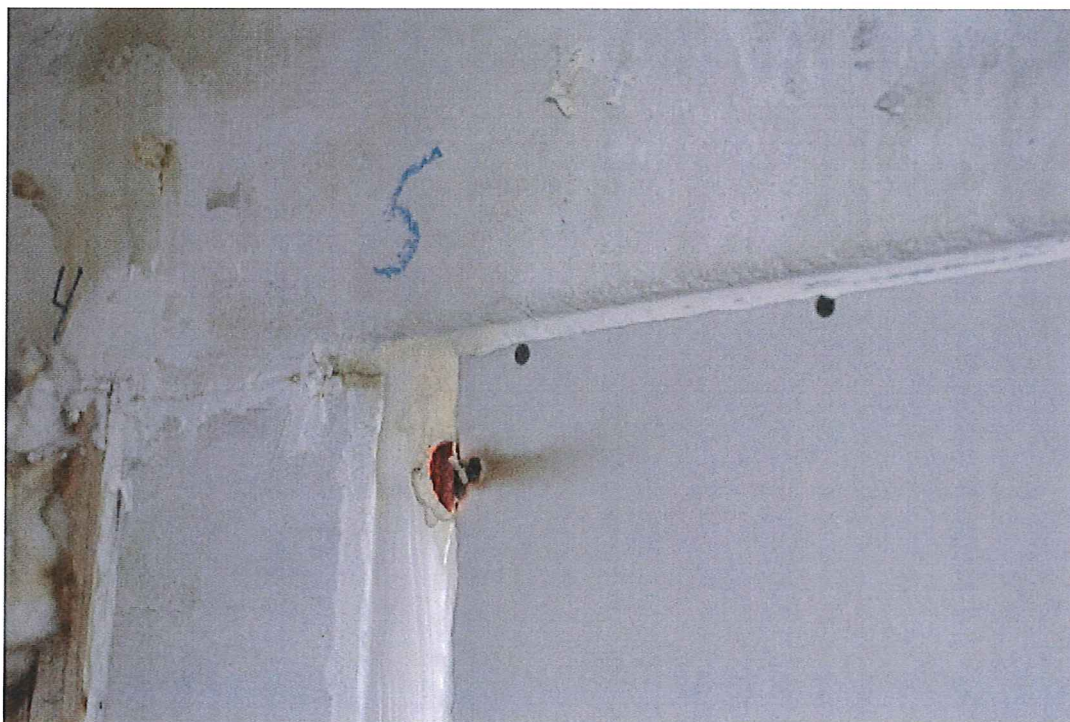
| 123 | 5 | Failure of integrity, due to trough going opening in the top of the sealant. Hole is stopped with ceramic wool. |

| Test specimen | Test results | | | | |
|---|---|---|---|---|---|
| 5 | 130 | - | - | 123 <sup>1</sup> | 123 |

Photo No. 12 Integrity failure at the top of joint seal 5 after 123 minutes of testing

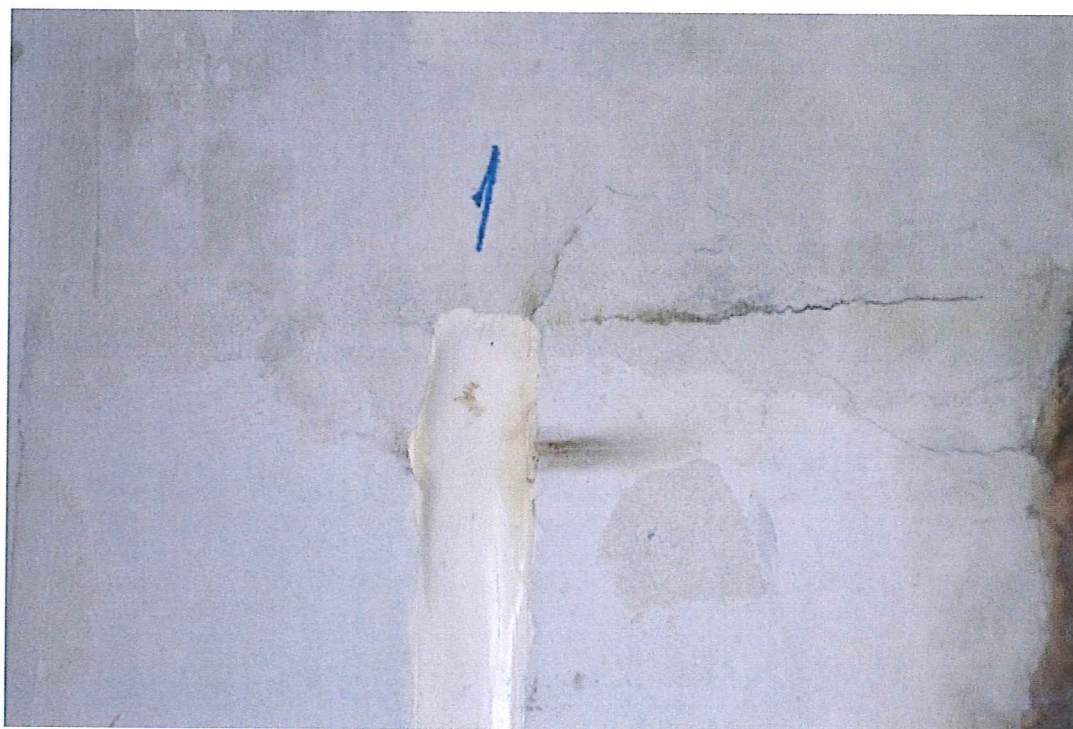
| 151 | 1 | Small opening along the top of sealant, weak smoke development. |
| 153 | 1 | Failure of integrity, due to trough going opening in the top of the sealant. |

| Test specimen | Test results | | | | |
|---|---|---|---|---|---|
| 1 | - | - | 97.1 | 153 | 153 |

Photo No. 14 Integrity failure at the top of joint seal 1 after 153 minutes of testing
